JNS Normal Procedure

“Accident Gotthard base tunnel - broken wheels”

Final report | version 3.0 | 04.04.2025

Outcome of the Joint Network Secretariat Normal Procedure “Accident Gotthard base tunnel - broken wheels”

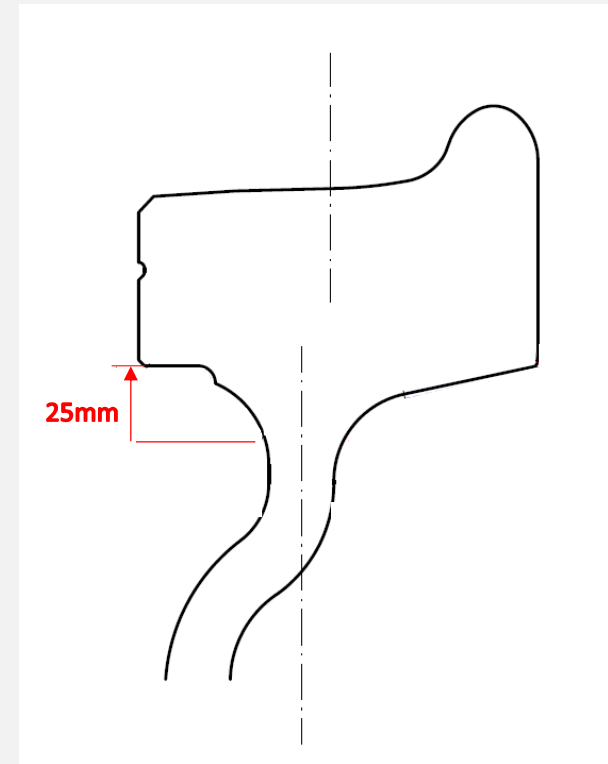
- Burnt paint (cracks or shelling on paint) or no paint or corrosion (trace of rust) of more than approximately 25 mm measured along the wheel radius, starting from the edge of the wheel rim towards the wheel web (see blue marking of figure to the right)
- Fusion of brake blocks
- Deterioration of wheel tread with build-up of metal
- Uneven blueish appearance on the rim

Affected ECMs and all freight Railway Undertakings shall consider any available data from detection devices (e.g. hot wheel detectors, ..) that might indicate thermal overload.

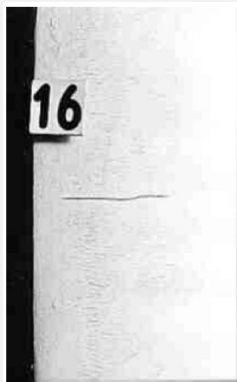
Description: The tread exhibits cracks at an angle of approximately 90° to the circumference of the wheel and have a typical length of 30mm or more. Transverse cracks generally develop at the surface in either straight or slightly crooked lines and can penetrate radially (usually of thermal origin in these cases) or branch out in a circumferential direction (usually of mechanical origin in this case). They occur individually and can be distributed at several points around the circumference. [EN 15313, §C.2.6]

Transverse crack revealed by magnetic particle testing [EN 15313, §C.2.6]

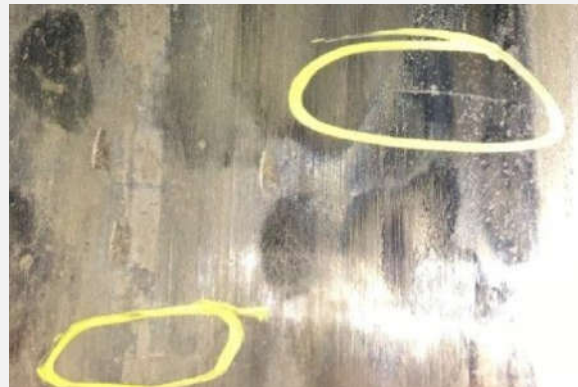
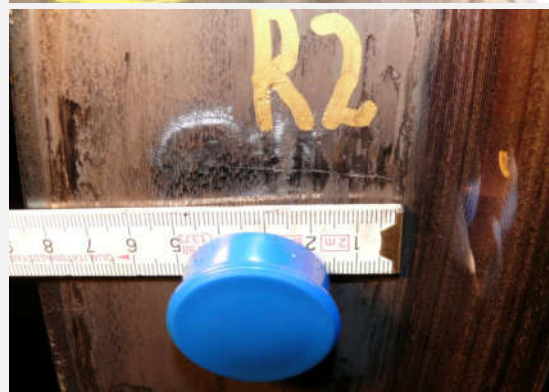
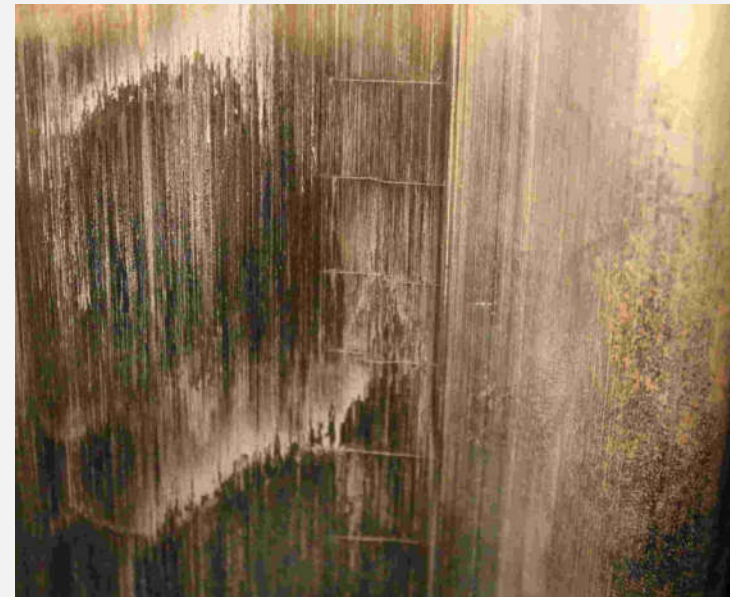
Reference “single cracks on the wheel tread” (1/3)

Example for single cracks on the wheel tread by visual inspection

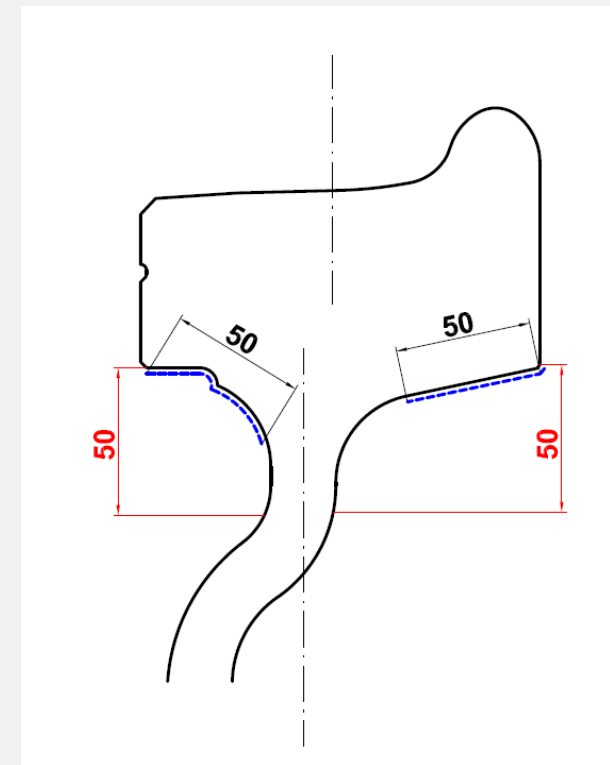
In the GCU, Appendix 9, Annex 1 the size of burned paint is defined with “50 mm or more”. Different interpretations are possible.

- reduce the red length from 50 to e.g. 25 mm => *comparison of the radial length for existing wheels*
- Better radial direction as near the contour, because different wheel designs
- Or use only “marked bunt paint” like JNS proposal 2019

Recommendation: Apply definition 1 or adapted proposal and prepare proposal for GCU amendment
