JNS Normal Procedure

“Accident Gotthard base tunnel - broken wheels”

Final report | version 3.0 | 04.04.2025

Outcome of the Joint Network Secretariat Normal Procedure “Accident Gotthard base tunnel - broken wheels”

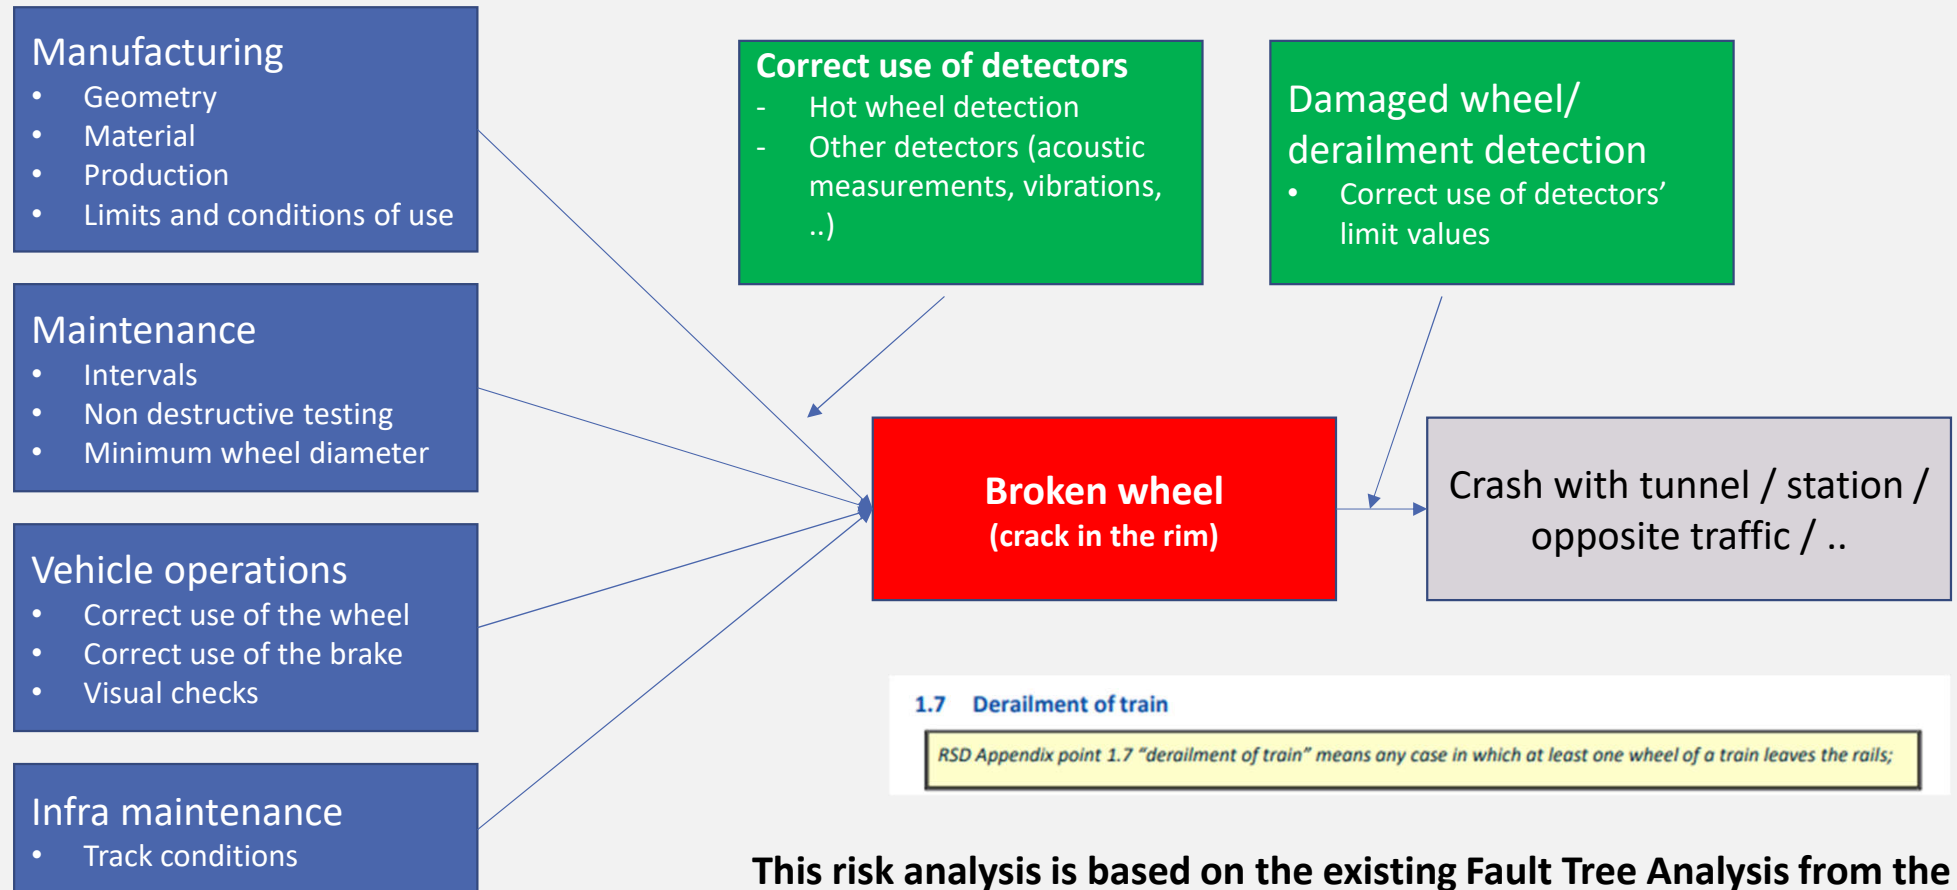
Risk to be tackled in the Normal Procedure

This risk analysis is based on the existing Fault Tree Analysis from the JNS NP Broken Wheels 2017-2019 (for "crack in the rim" cases)

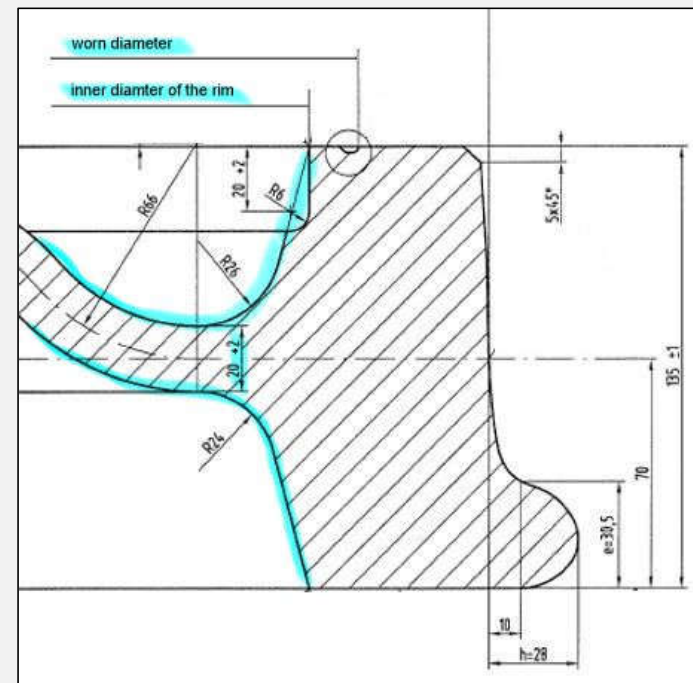
Figure: drawing of BA 004 showing design features referred to in the criteria

The criteria concern the combination of three special design features of wheel type BA 004 of the contour in the transition from rim to web and the minimum allowed residual cross section area of the rim, identified within the analysis of the known cases of cracked and broken wheels.

Criteria
1. Radii in the transition between rim and web comparable to wheel type BA 004 (see figure)
2. Position of the web nearly in the middle of rim (see figure)
3. Allowed thickness of the web near the rim equal to or greater than 20 mm and equal to or smaller than 22 mm (see figure)
4. Minimum residual rim cross section area (in fully worn state) in accordance with chapter 4.3.1 of EN 13979-1 is lower than 0,23 dm ² .

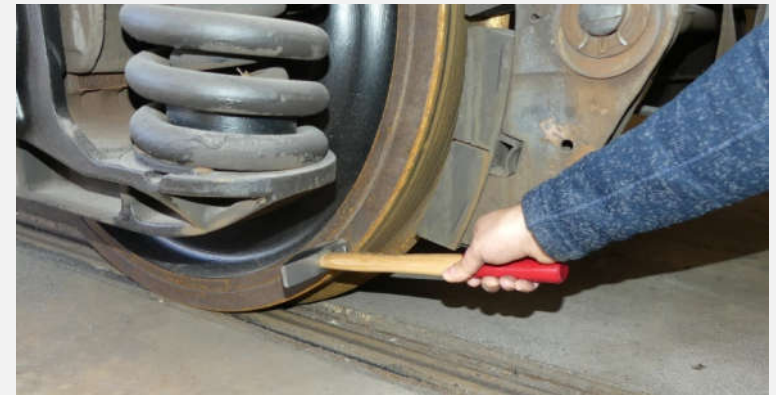
- Wheel responds with a thud-like/damped sound: crack from the rim to the web (independently from the position of the cracks over the circumference);
Important: defects on the tread (without cracks propagated to the web) cannot be detected;
- Wheel responds with a ringing sound: no cracks from rim to web (independently from the wheel type (web shape) and wheel diameter).

- The sound test shall be done by qualified staff, e.g. wagon inspector;
- The sound test shall be done with a metal hammer;
- The sound test shall be done with fully released brakes;
- The sound test shall be done at the outer side of the rim's circumference in the following areas (see photo) expressed in terms of clock time:
 - between 1 and 5;
 - Between 7 and 11;
